**CONSENT ORDER
ISSUED UNDER THE
WATER POLLUTION CONTROL ACT
WEST VIRGINIA CODE, CHAPTER 22, ARTICLE 11**

TO: MarkWest Liberty Midstream & Resources, L.L.C. DATE: March 28, 2019
Gregory Bezdek, SVP, NE Region
4600 J Barry Ct. Ste 500
Canonsburg, PA 15317 ORDER NO.: 8945

MARKWEST LIBERTY MIDSTREAM & RESOURCES, L.L.C, WVR311004, Sherwood to Mobley
20" NGL, 8/22 & 8/23/2018

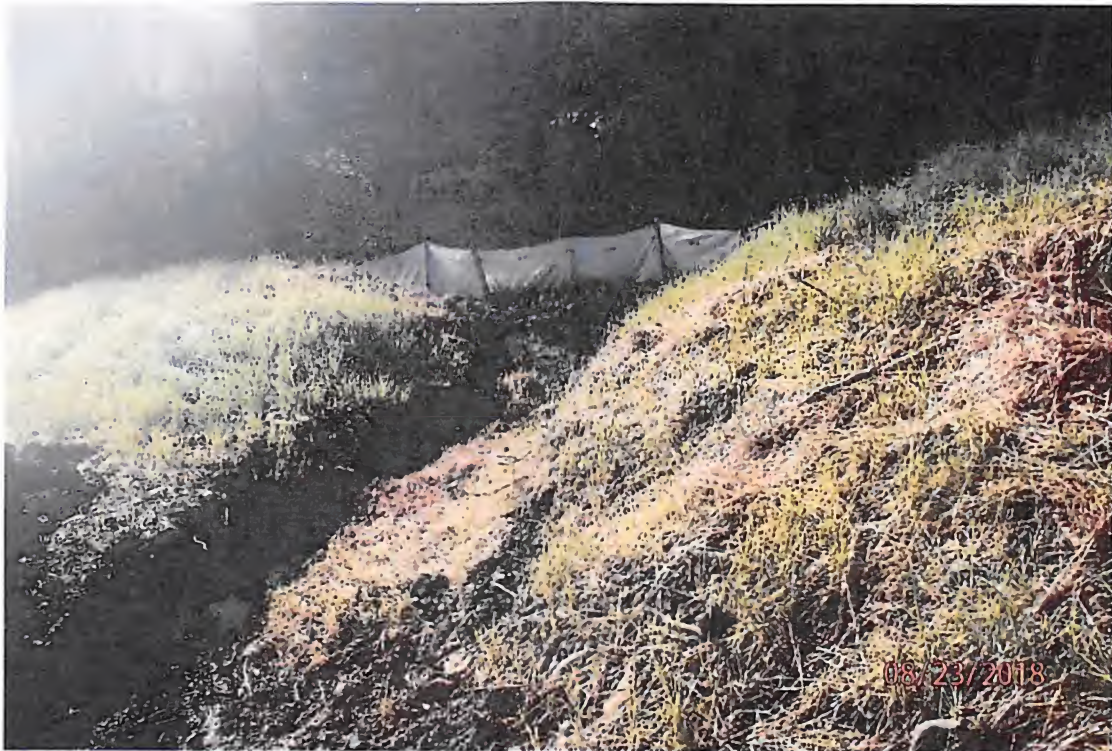
Overwhelmed water bar terminus BMP as a result of excessive erosion and increased water velocity from the above pictured water bar.

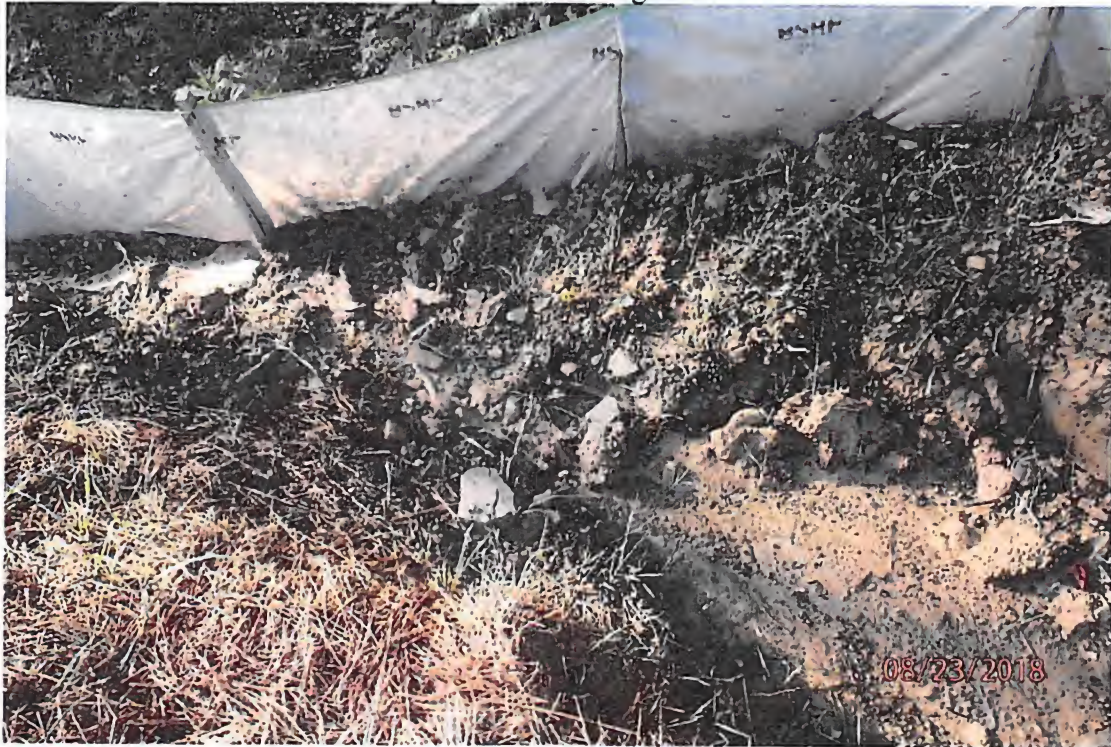
Improperly installed water bar near 857+00 that does not shed stormwater off of the LOD in small quantities as designed.

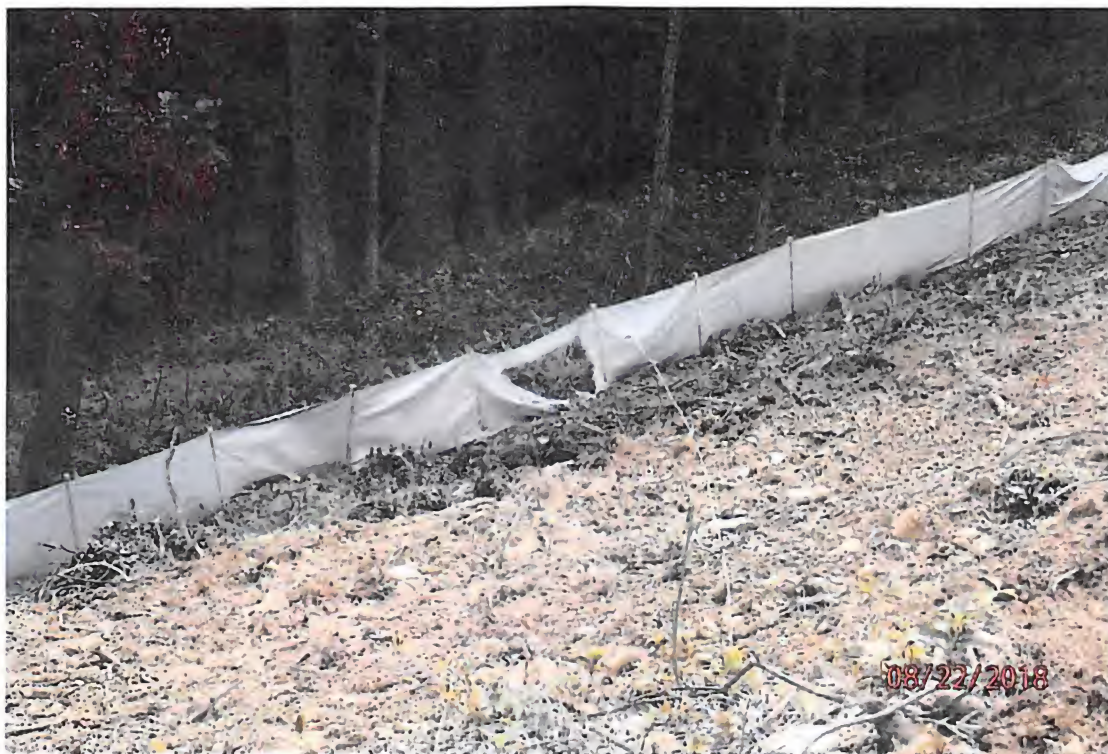
Improperly installed water bar near 857+00 that terminates prior to the installed perimeter controls and does not shed stormwater off of the LOD in small quantities as designed.

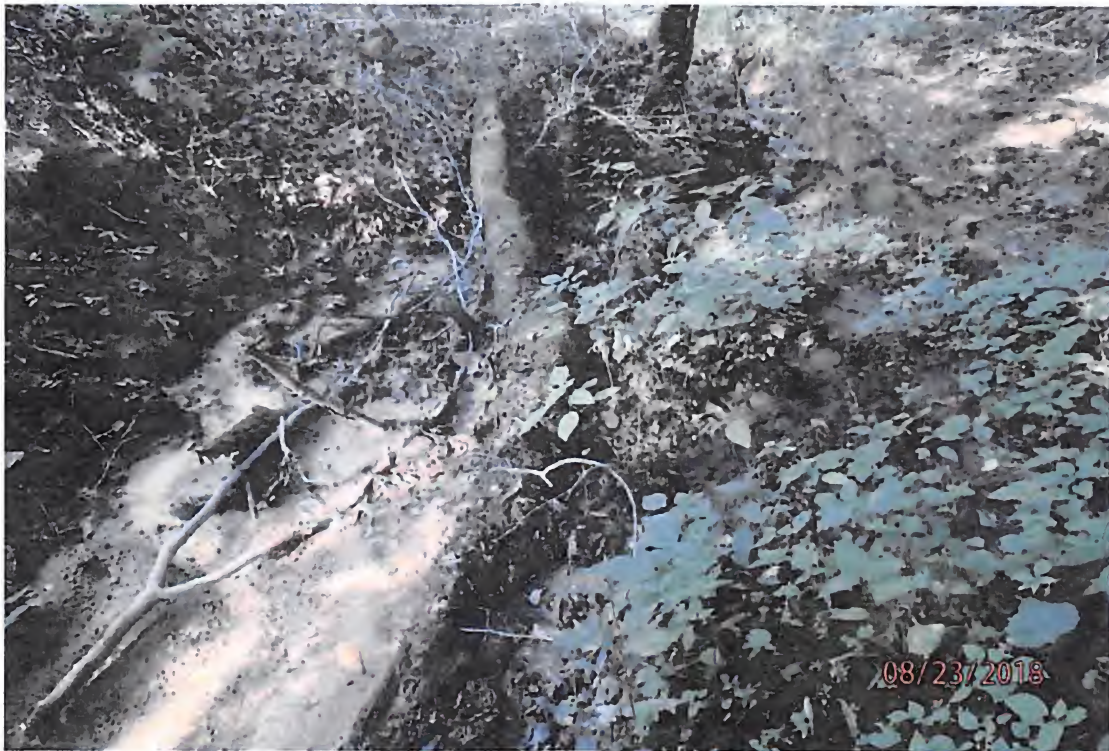
Offsite sediment deposits that lead to the receiving stream as a result of the above pictured deficiency.

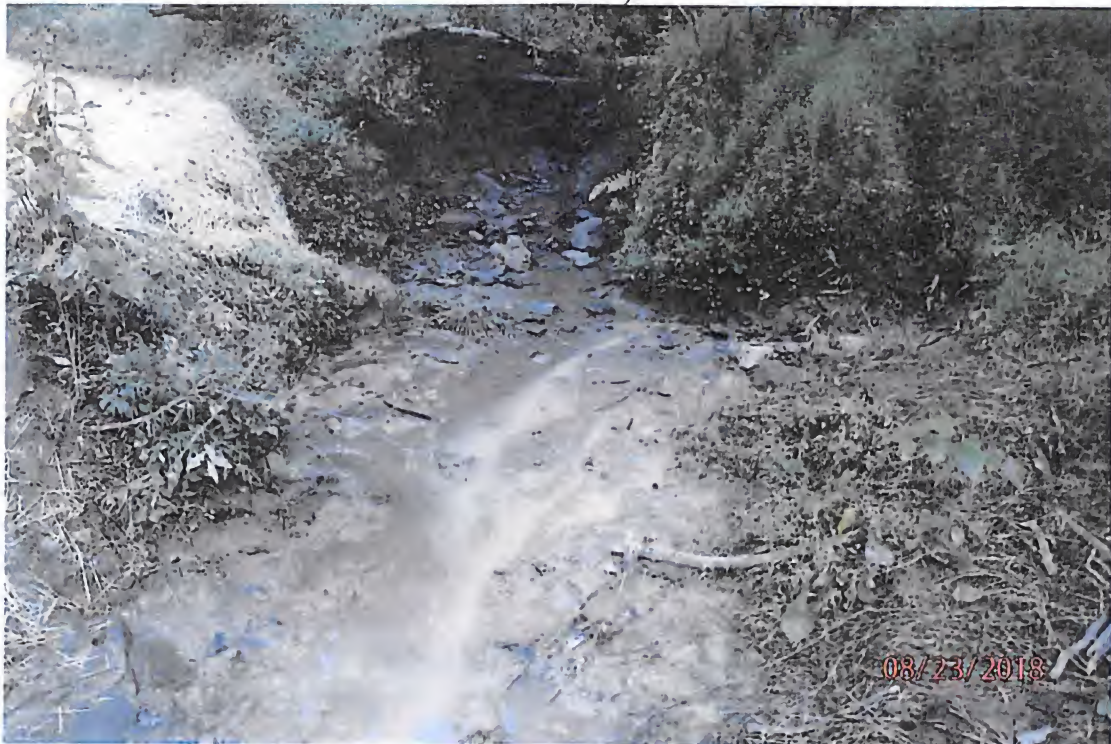
CNA deposits and distinctly visible settleable solids in UNT Beverlin Fork (UNT 129) ($39^{\circ} 26.346'$ X $80^{\circ} 36.157'$).

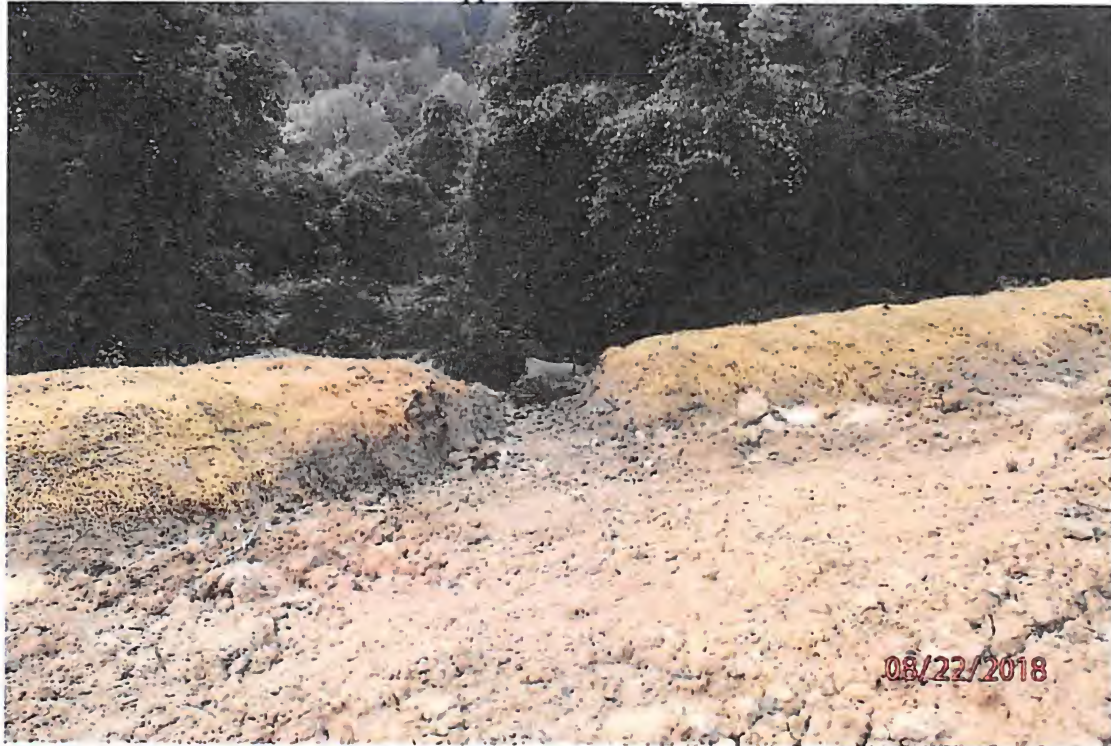
Installed diversion berm near 57+00 that lacks adequate outlets. Area also lacks water bars on the approved SWPPP.

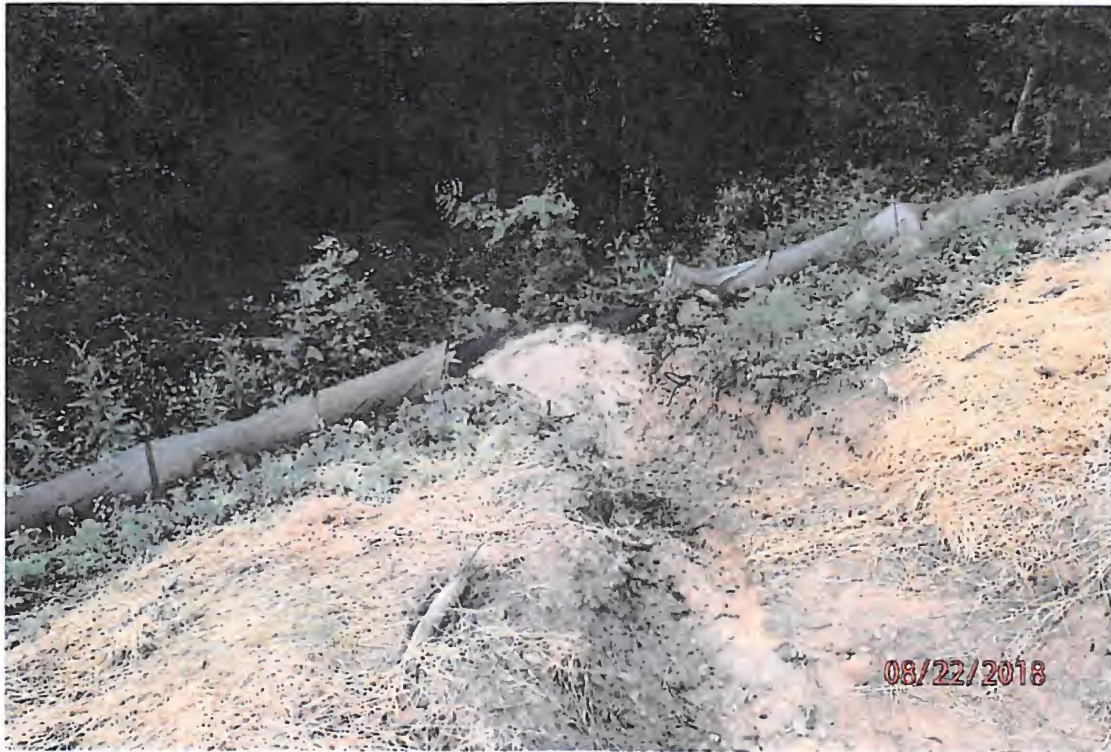
Diversion berm outlet near 57+00 that has been overwhelmed. Offsite sediment deposits were noted.

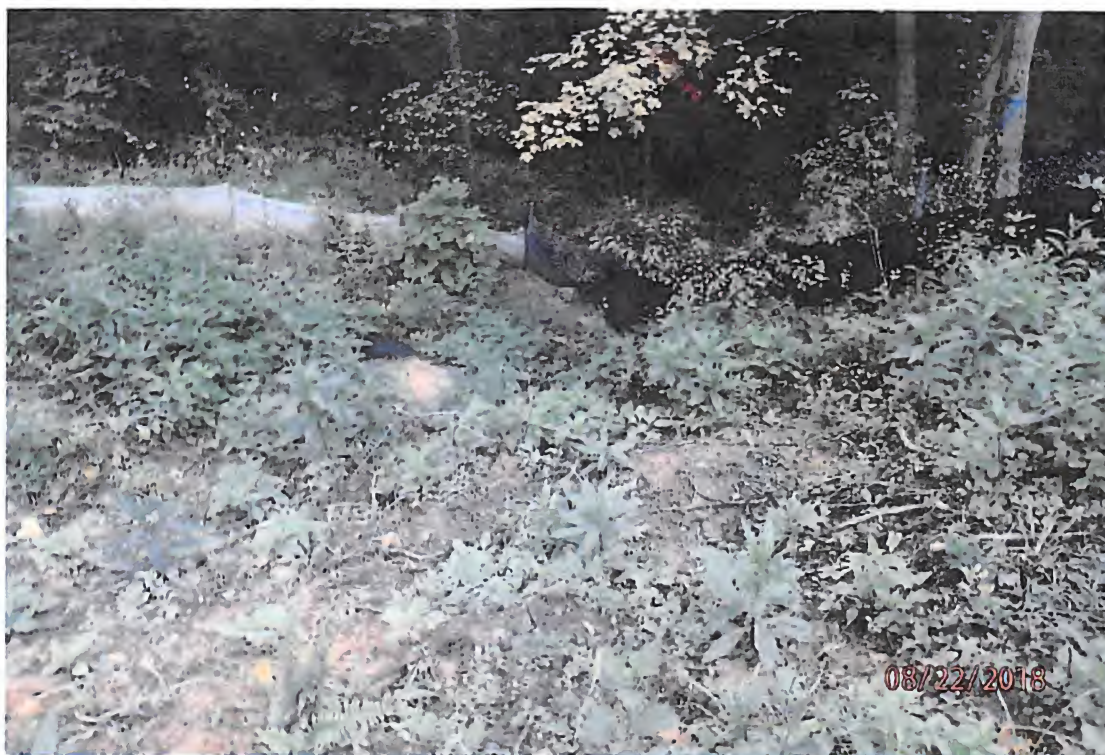
Installed diversion berm in the Morgans Run watershed that lacks adequate outlets.

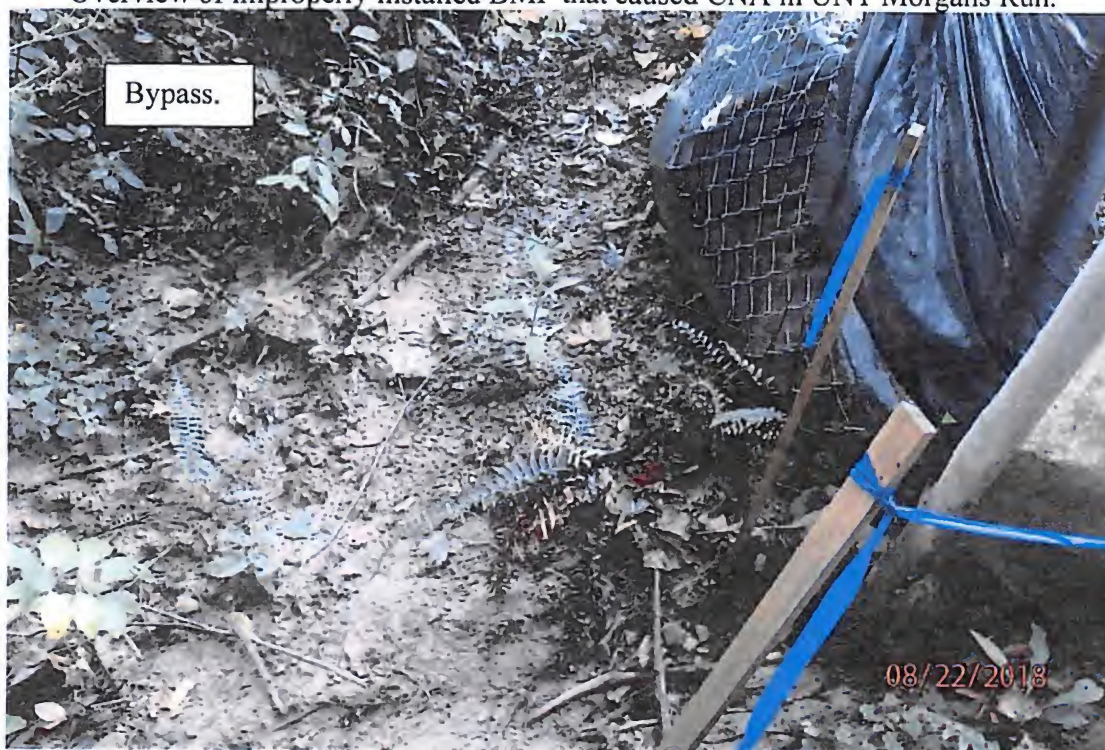
Overview of improperly installed BMP that caused CNA in UNT Morgans Run.

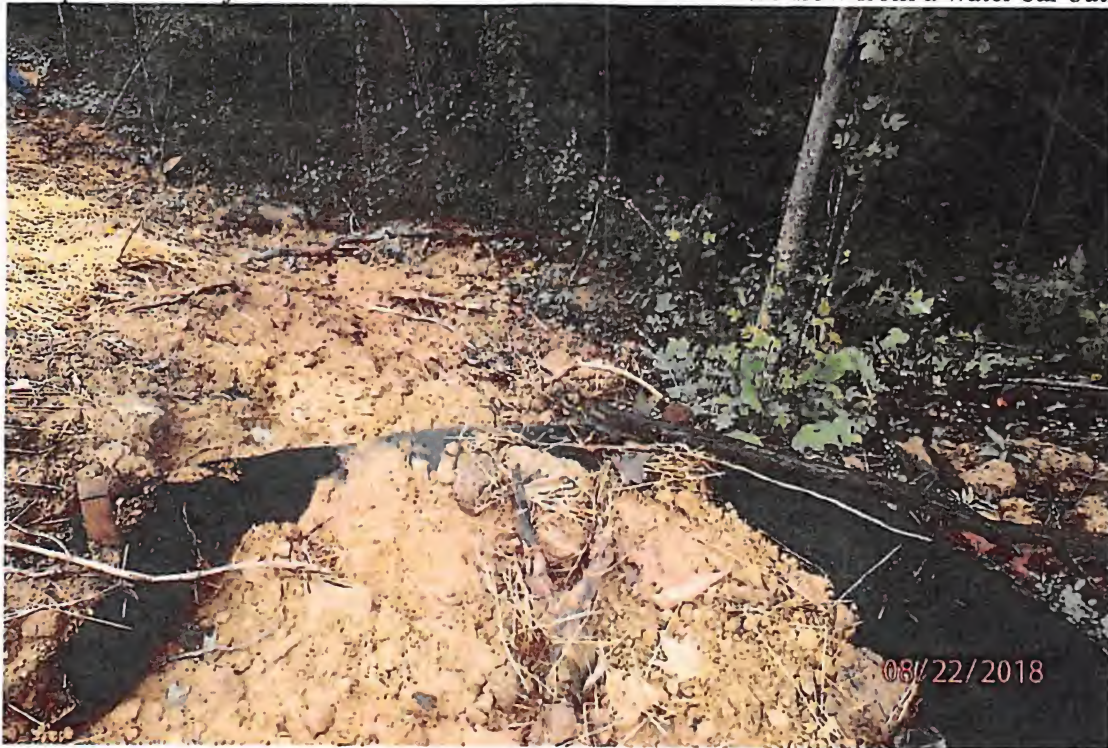
Fill slope erosion adjacent to UNT 108 as a result of concentrated flow from a water bar outlet.

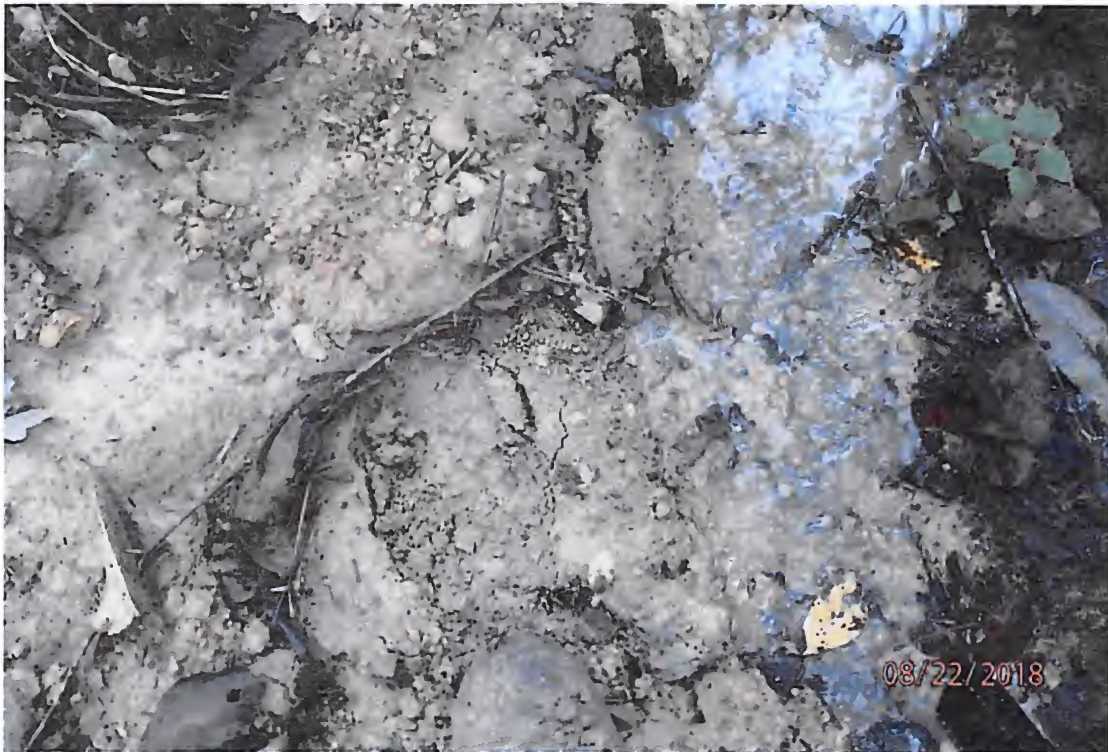
BMP that has been overwhelmed as a result of the above pictured fill slope erosion. Offsite sediment deposits leading to the receiving stream were noted.

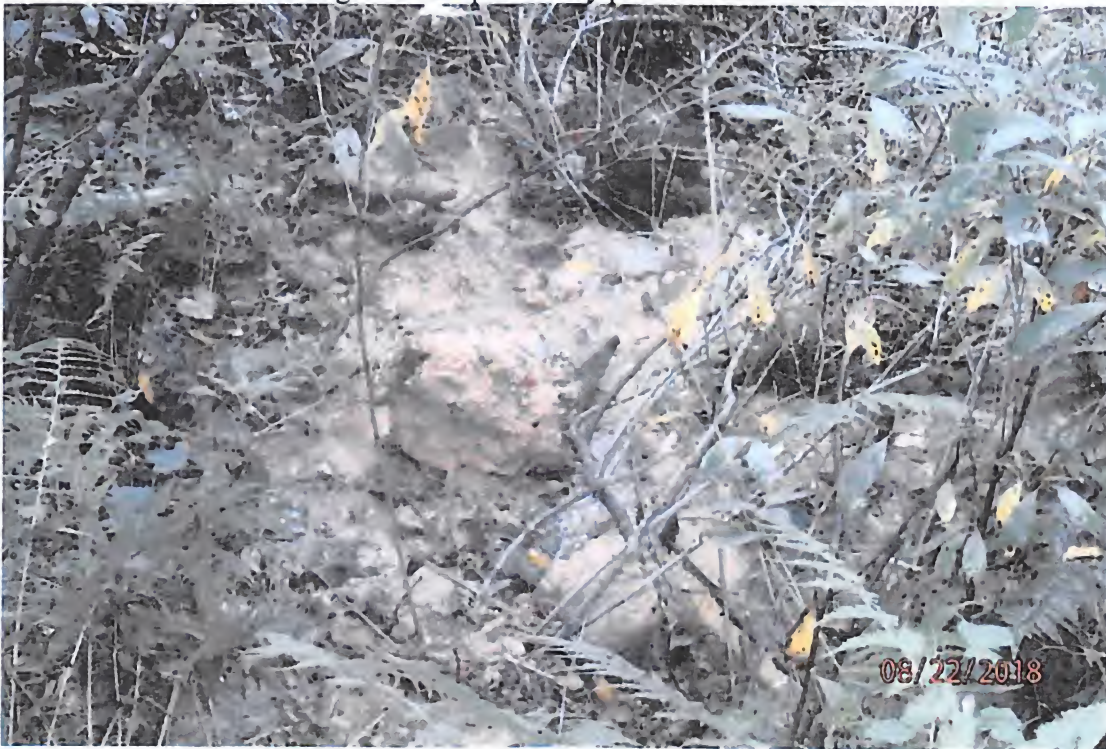
Offsite CNA deposits in UNT Righthand Fork of Morgans Run (UNT 108) (39° 17.955' X 80° 40.580')
resulting from the previously pictured deficiencies.

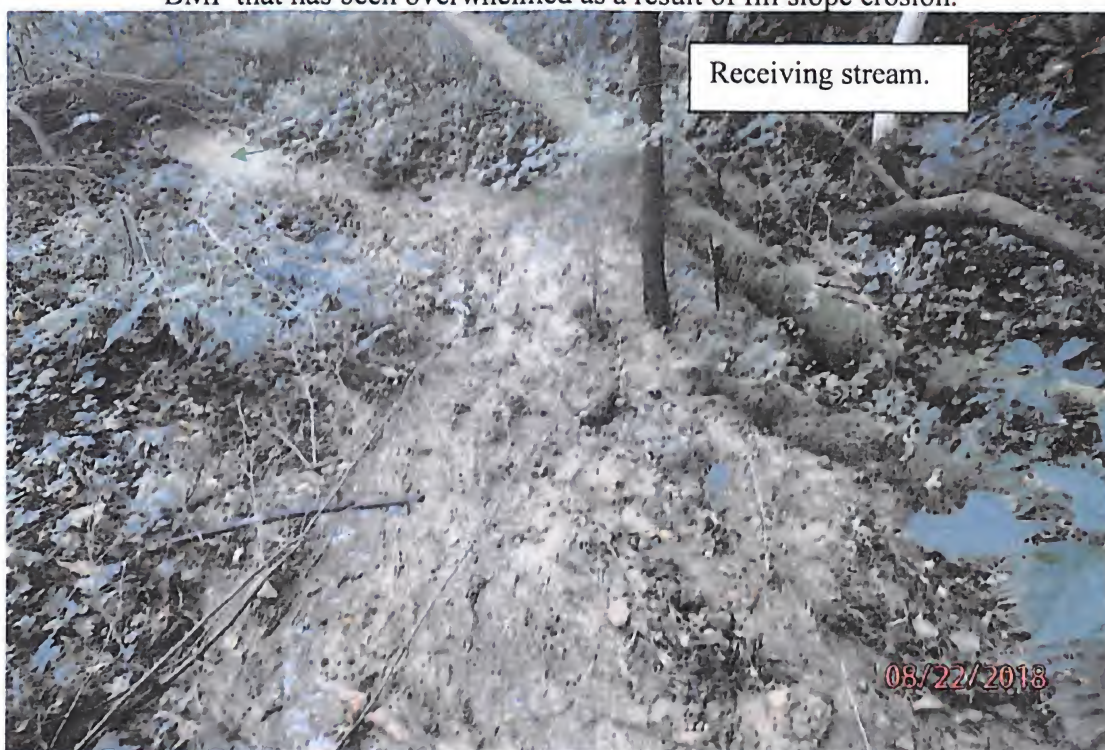
BMP that has been overwhelmed as a result of fill slope erosion.

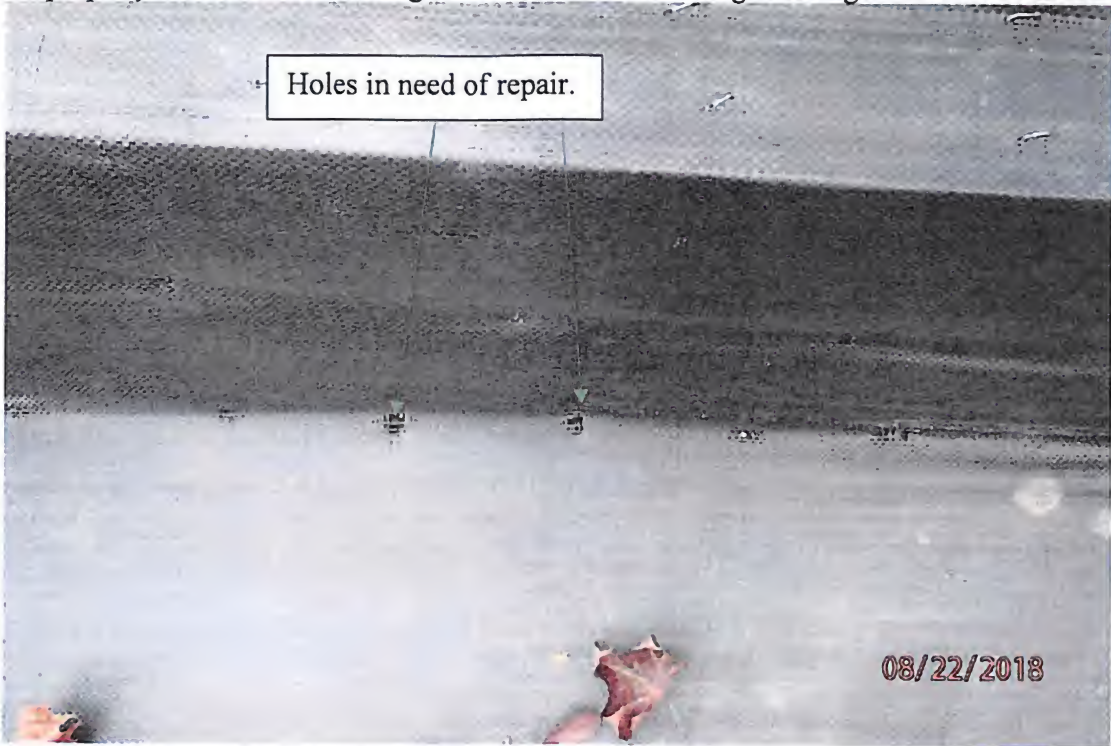
Improperly installed timber bridge at the Flint Run crossing showing maintenance needs.

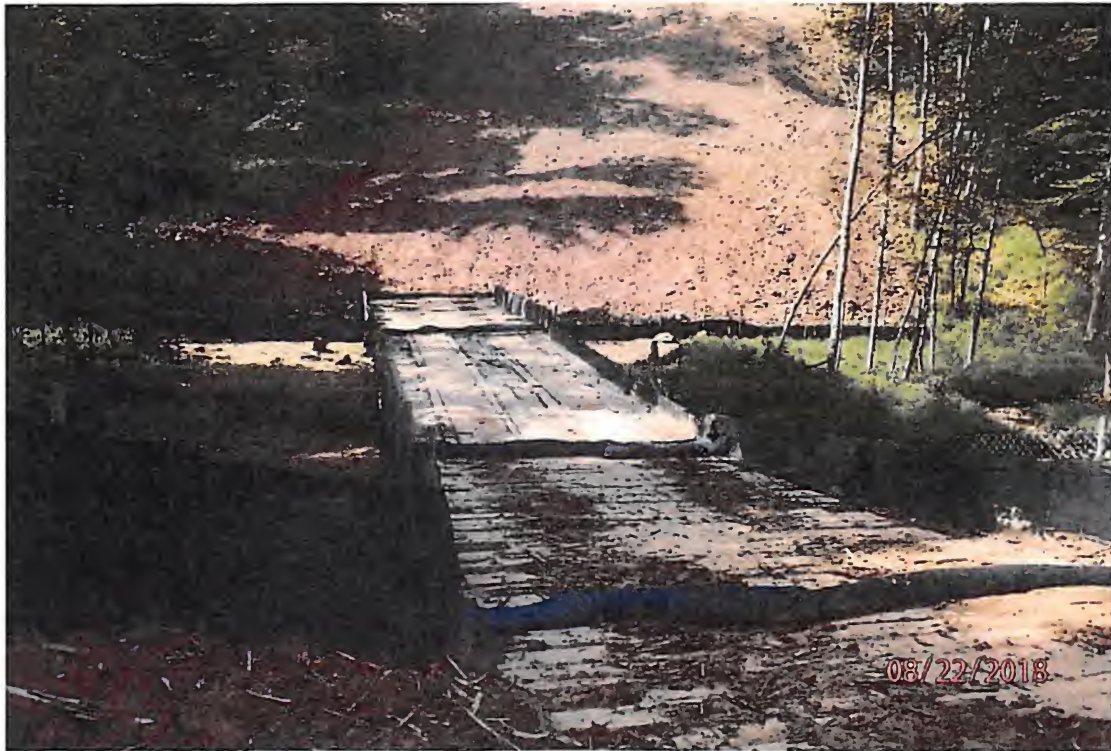
Improperly installed timber bridge at the Flint Run crossing showing maintenance needs.

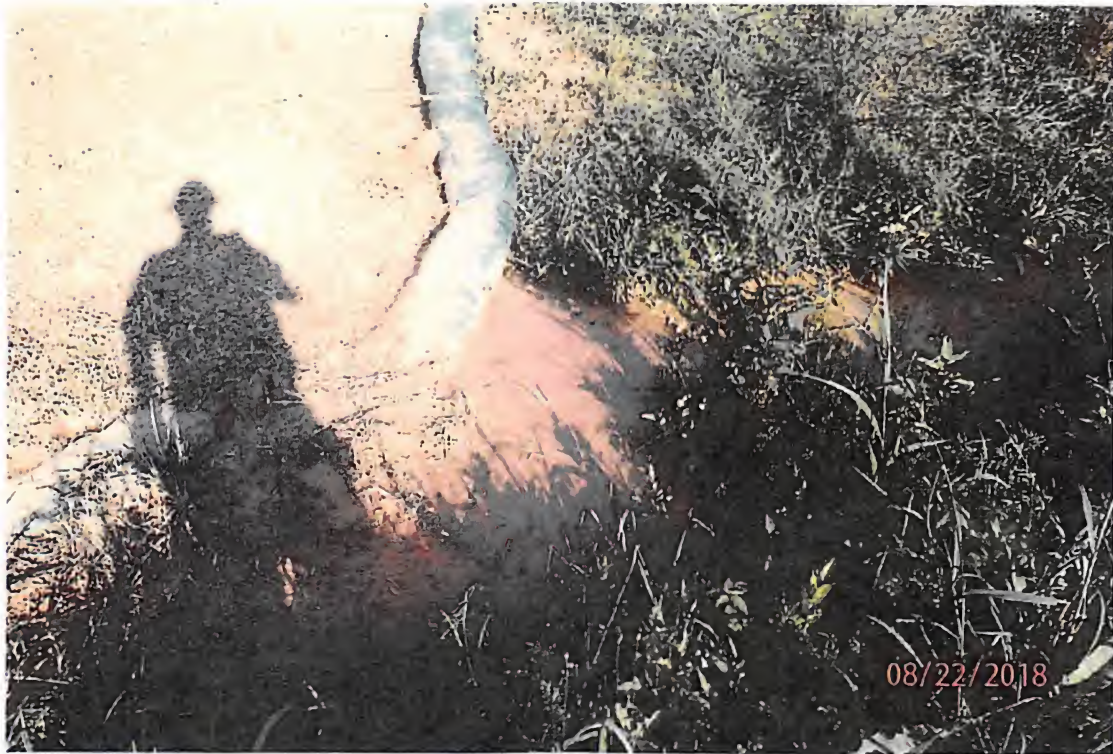
AR 40 showing a lack of stabilization that is described in the approved SWPPP.

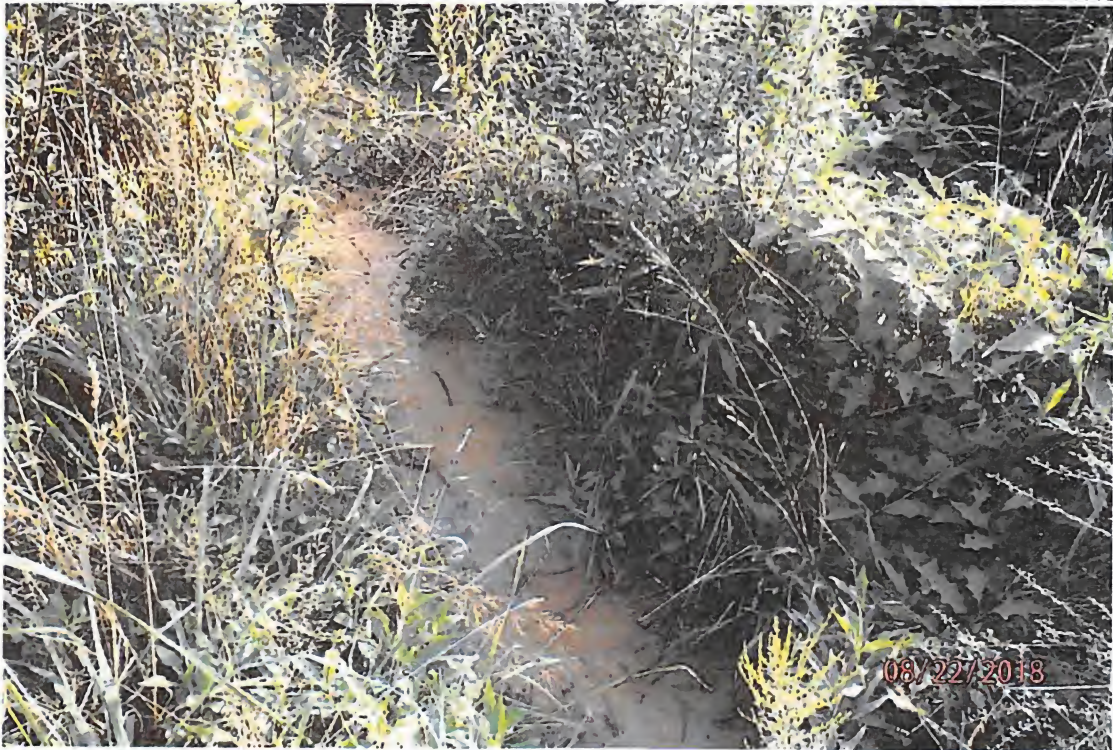
Offsite sediment deposits that lead to the receiving stream as a result of AR 40 deficiencies.

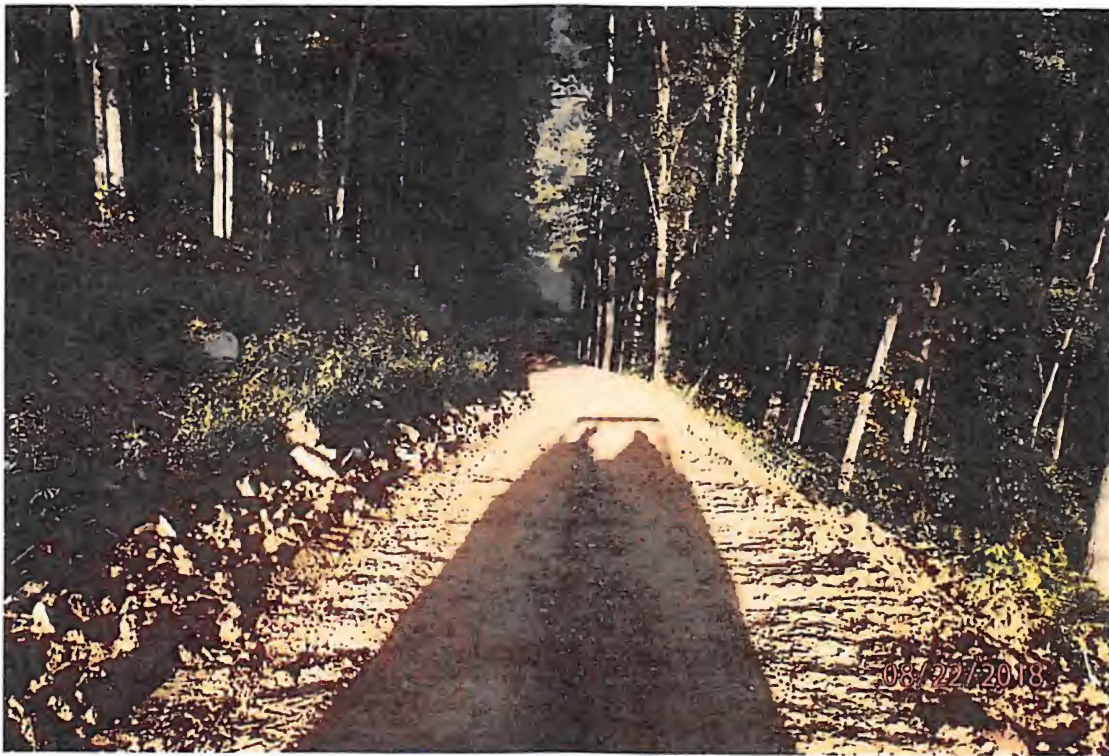
Offsite sediment deposits that lead to the receiving stream as a result of AR 40 deficiencies.

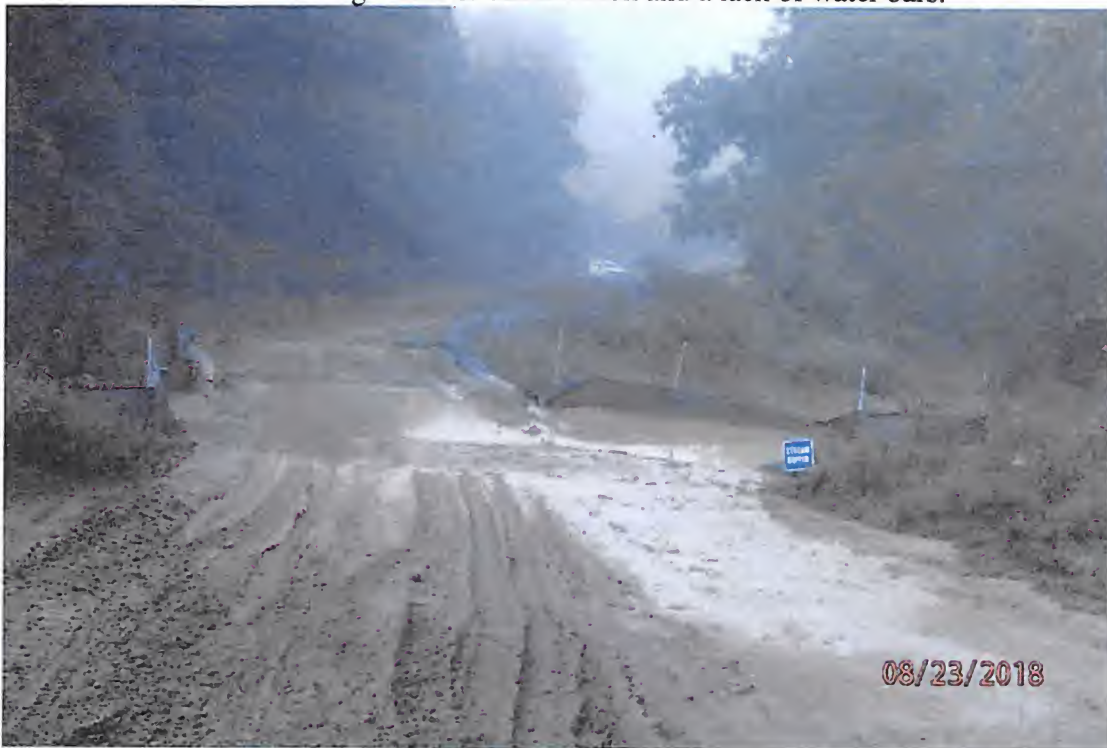
AR 40 showing a lack of stabilization and a lack of water bars.

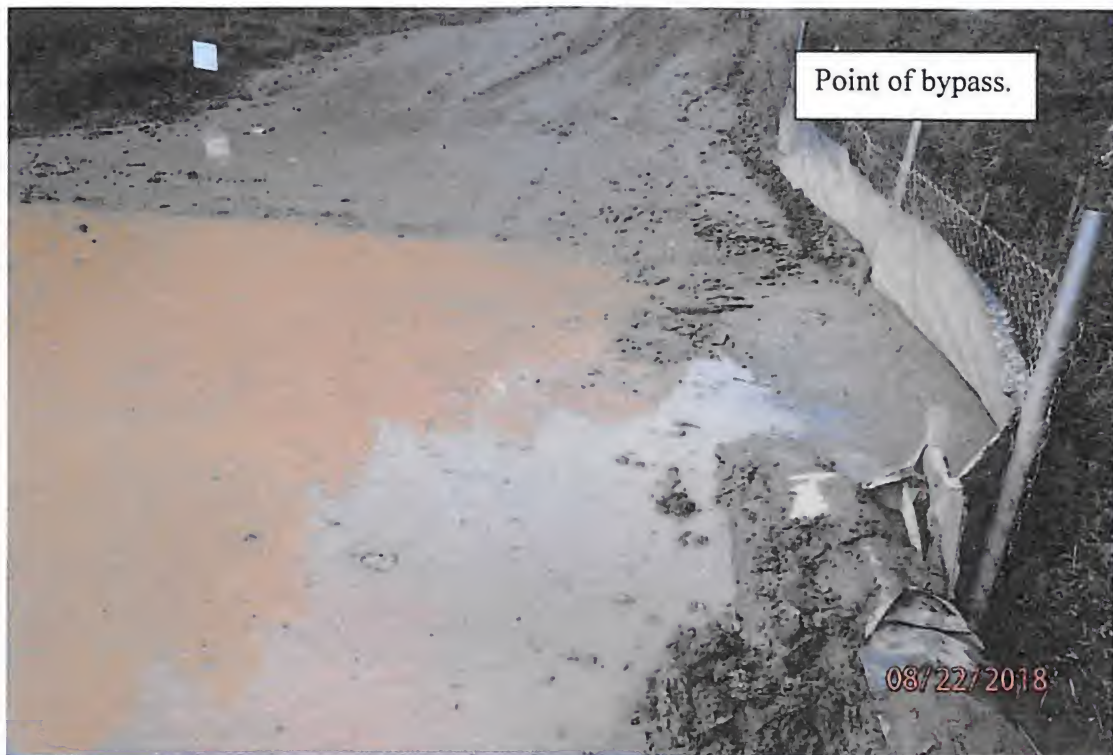
UNT 127 crossing on AR 40 showing area where CNA occurred as a result of above pictured deficiencies.

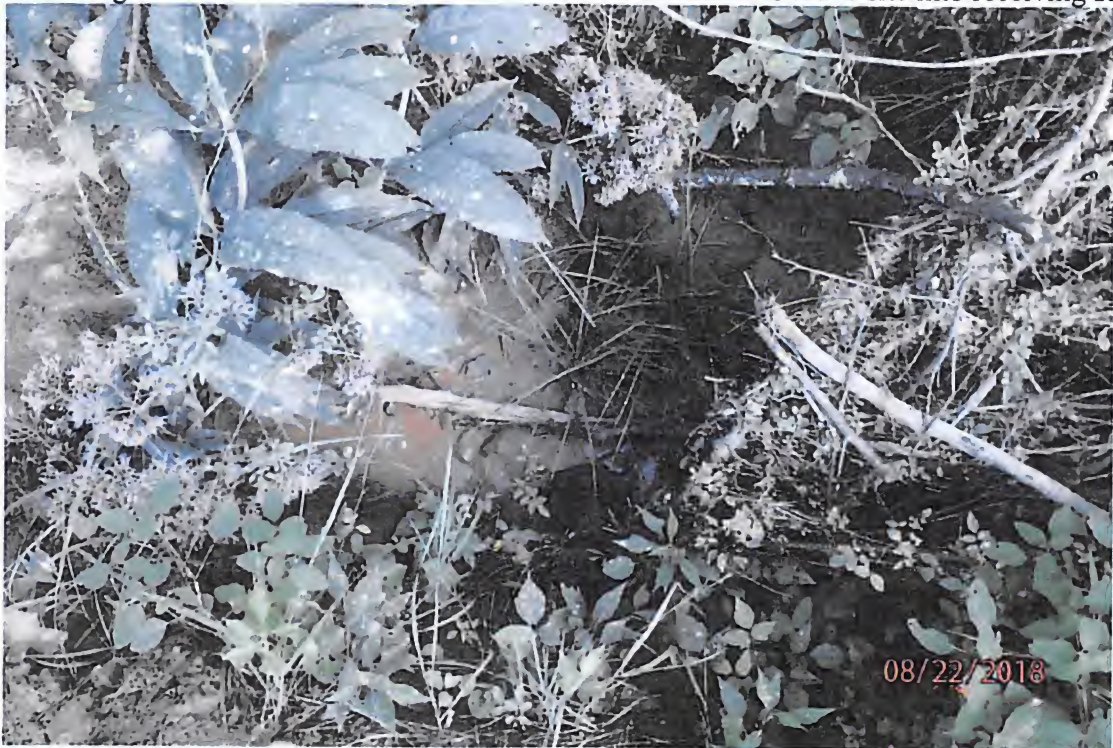
AR 40 crossing of UNT 127 where BMP failure allowed sediment to leave site into receiving stream.

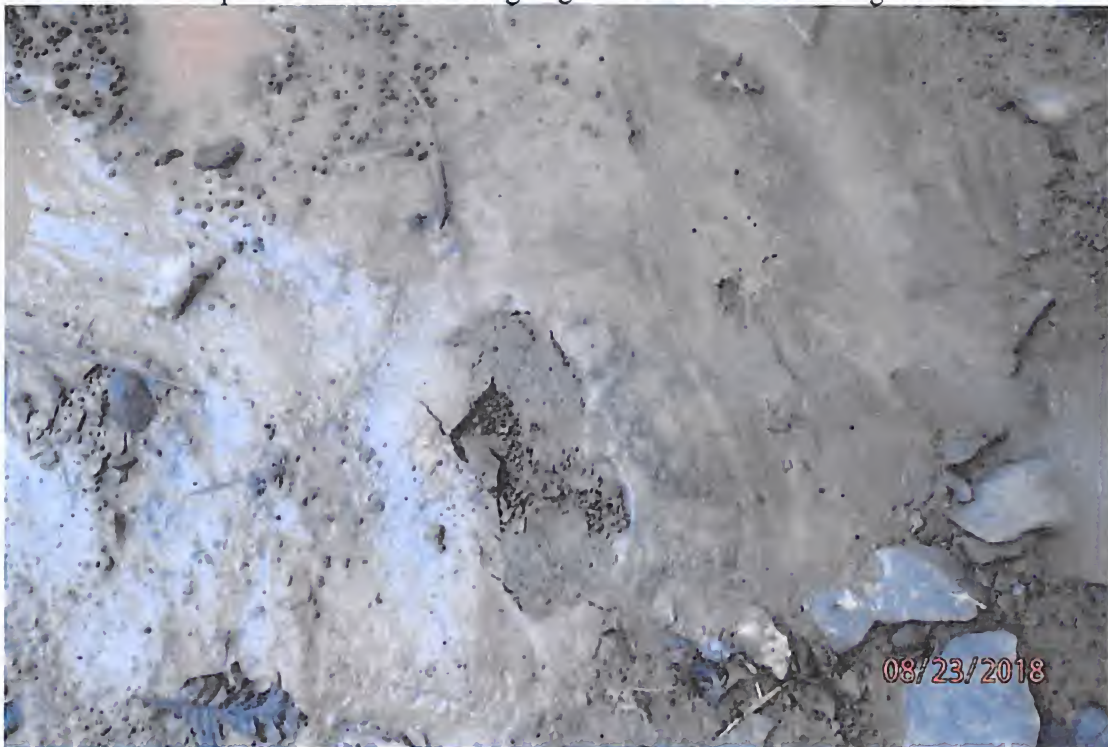
Offsite sediment deposits below dewatering bag that lead to the receiving stream at UNT 129.

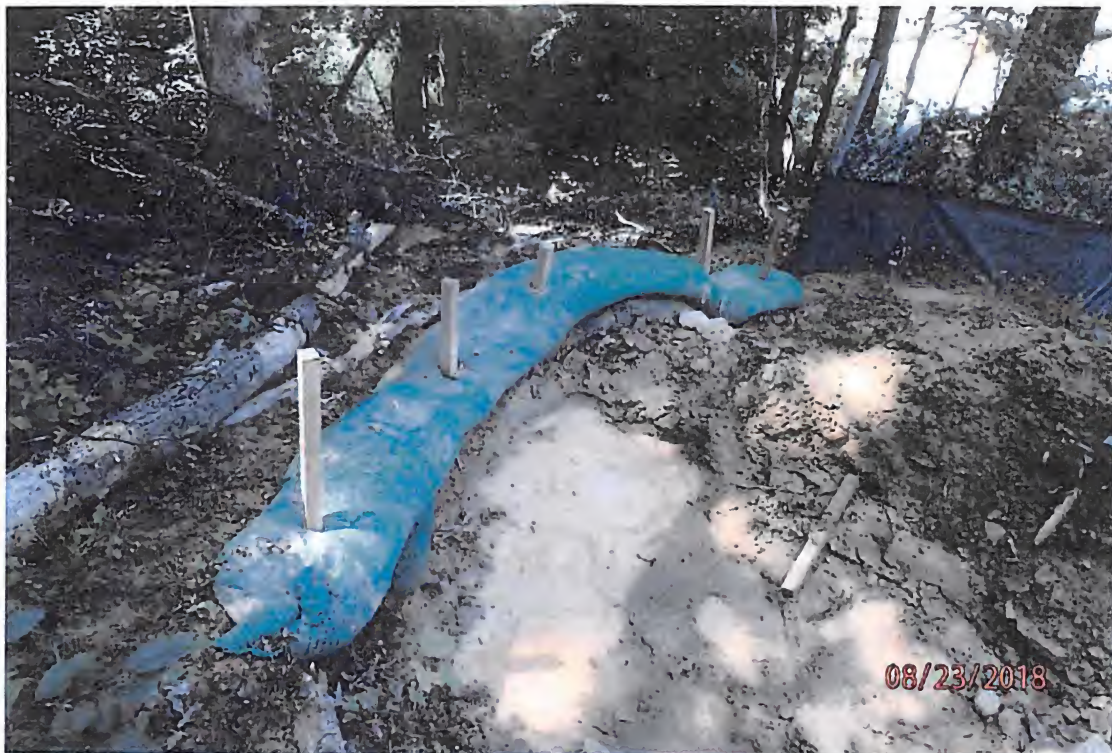
BMPs that were overwhelmed due to flow from the open pipe trench adjacent to crossing #23 (UNT 133) that led to offsite CNA.

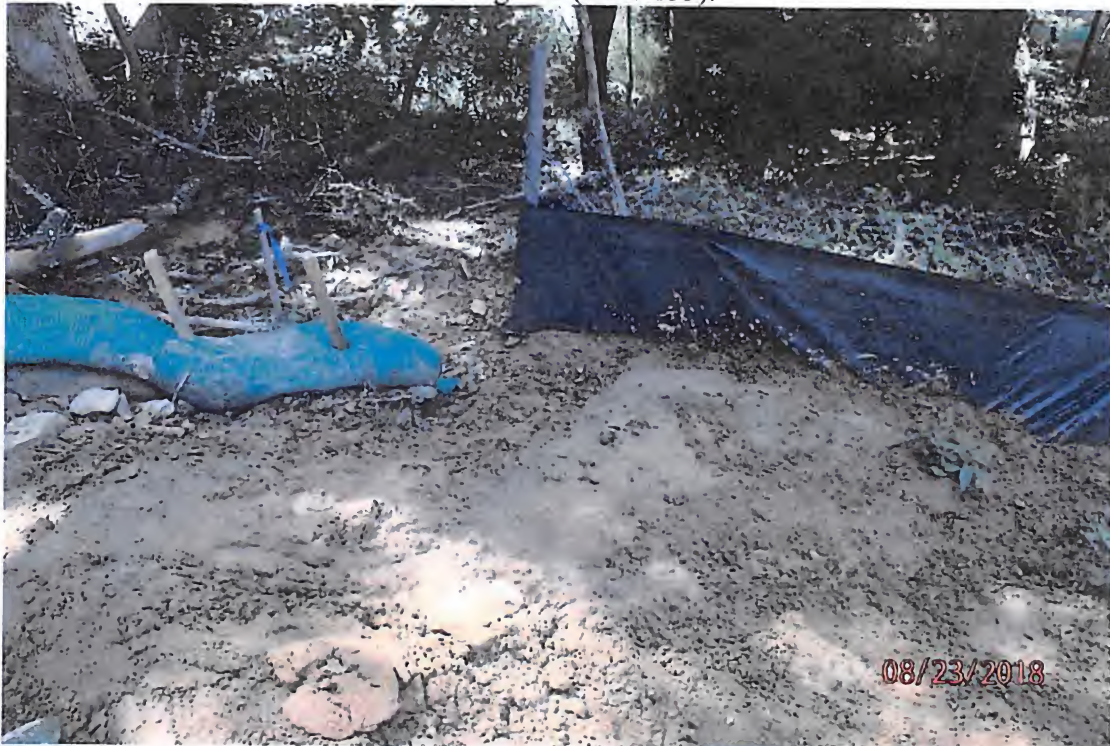
Improperly installed water bar terminus BMP that allowed sediment laden water to bypass it adjacent to crossing #23 (UNT 133).

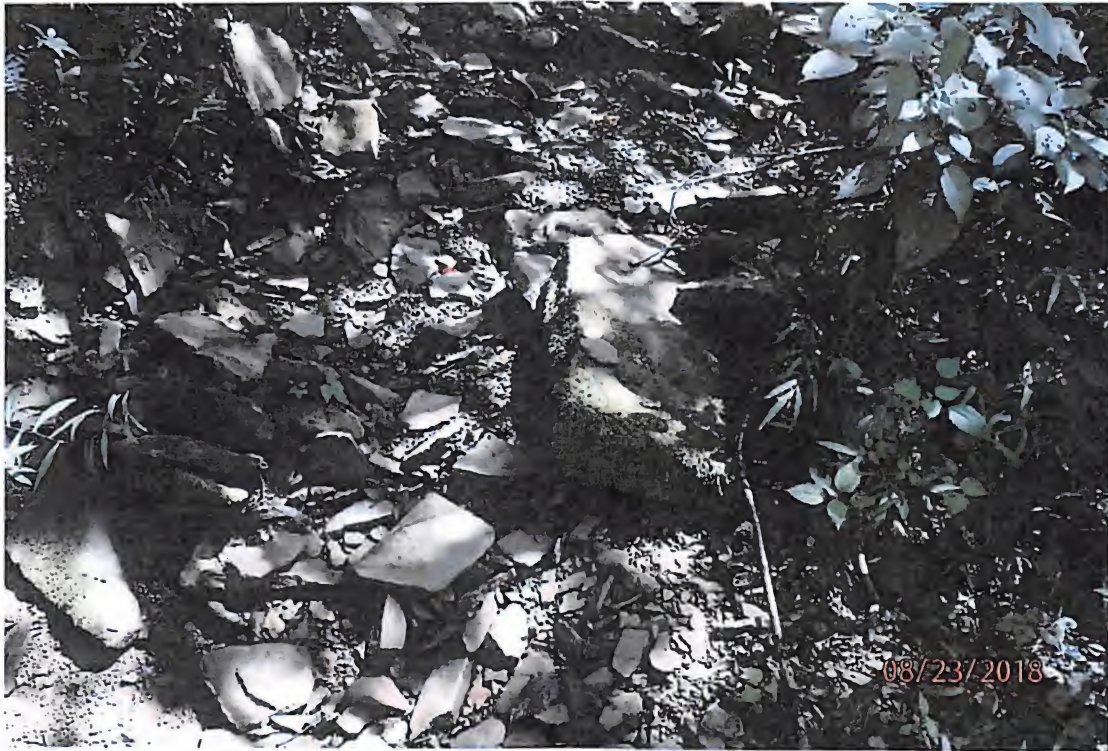
Improperly installed water bar terminus BMP that allowed sediment laden water to bypass it adjacent to crossing #23 (UNT 133).

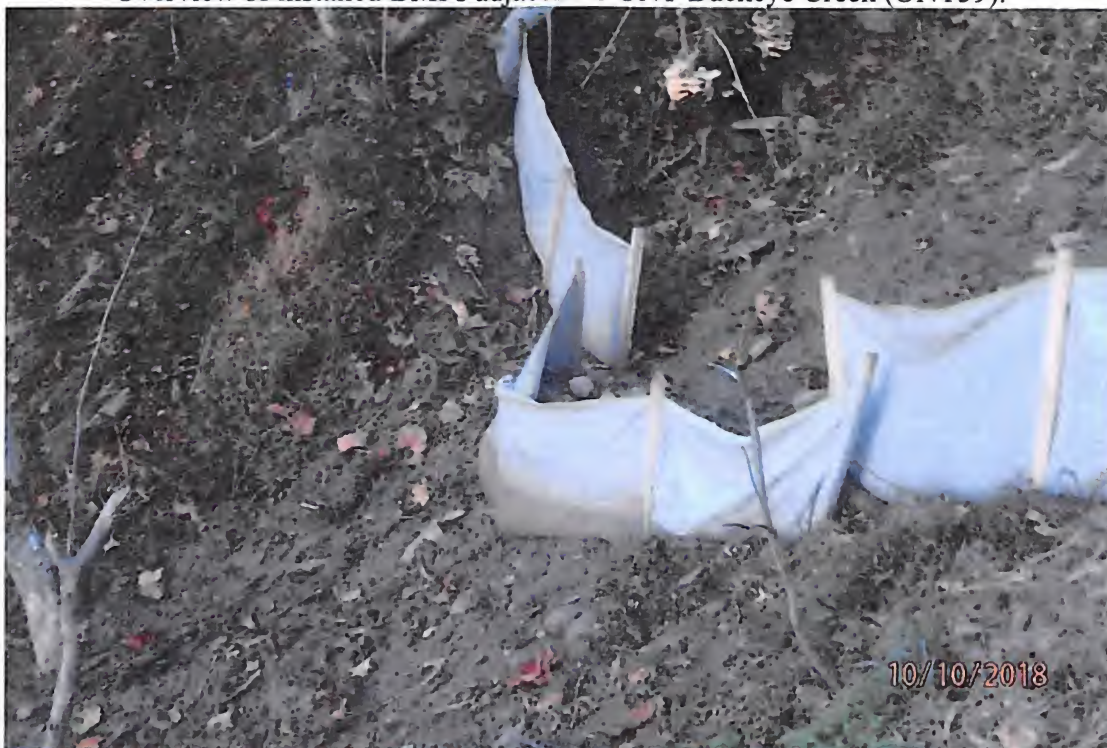
Overview of installed BMPs adjacent to UNT Buckeye Creek (UNT59).

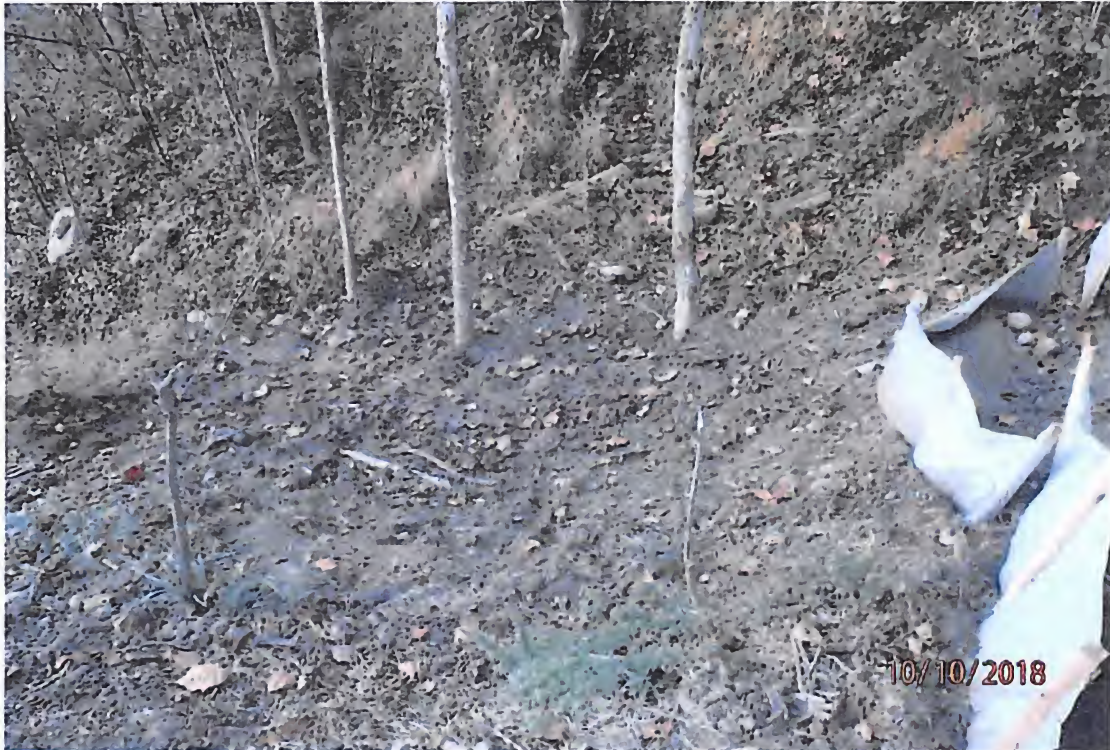
Overview of installed BMPs adjacent to UNT Buckeye Creek (UNT59) showing offsite sediment due to poor maintenance and improperly installed BMPs.
